# St James Church North Cray

## Application Document to support our need to restore the Church spire.

## **St James Church, North Cray**

### **Spire Condition Inspection**

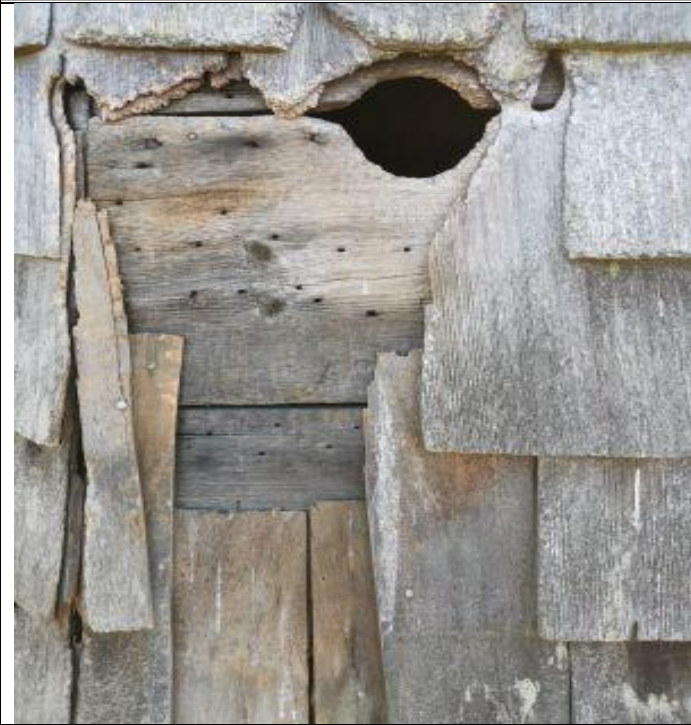
General view showing typical damage. Both loss of shingles and a hole penetrating the shingles and sarking boards.

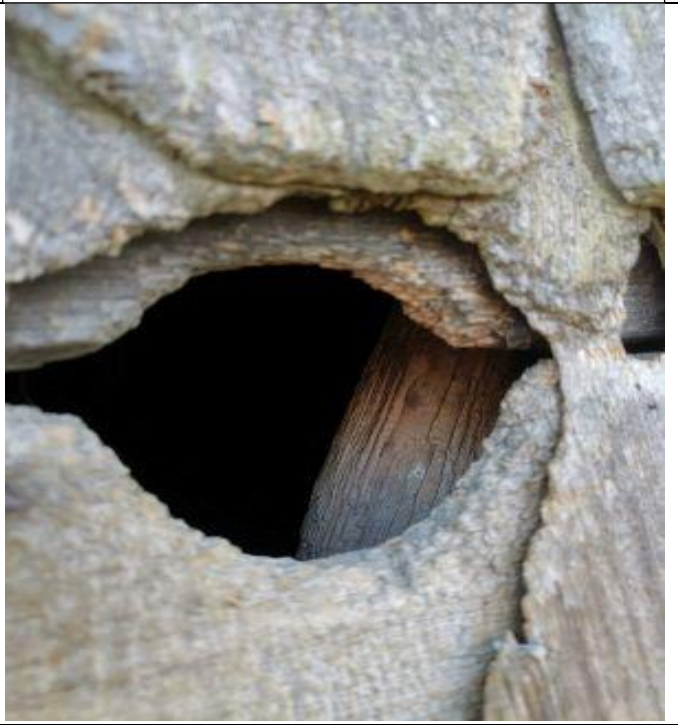
Detail. Hole started by Woodpeckers and then opened up by squirrels. This photo shows the inside of the spire now open to the elements

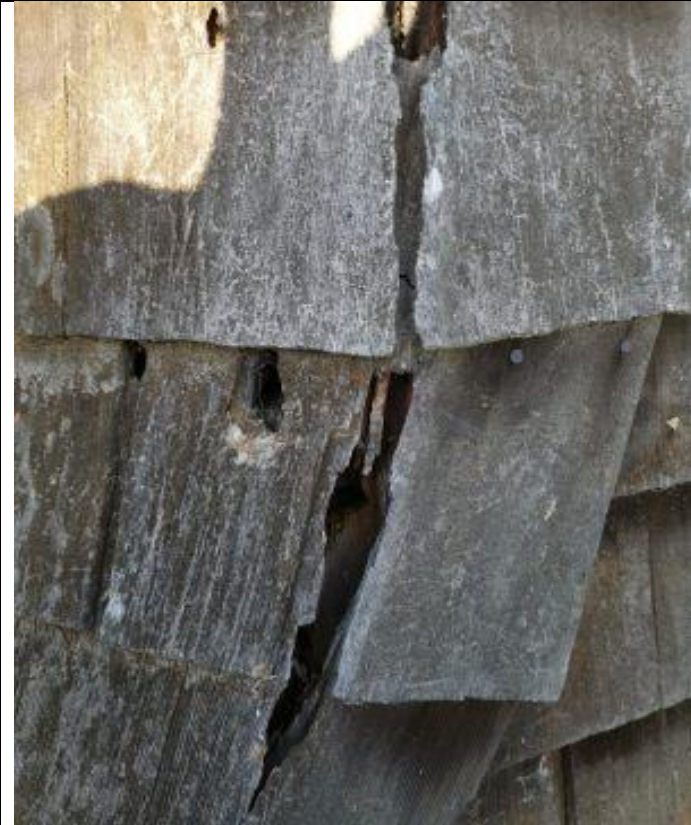
Vast evidence of woodpeckers and approx. 95% of all the mitred corners have been chewed away by squirrels.

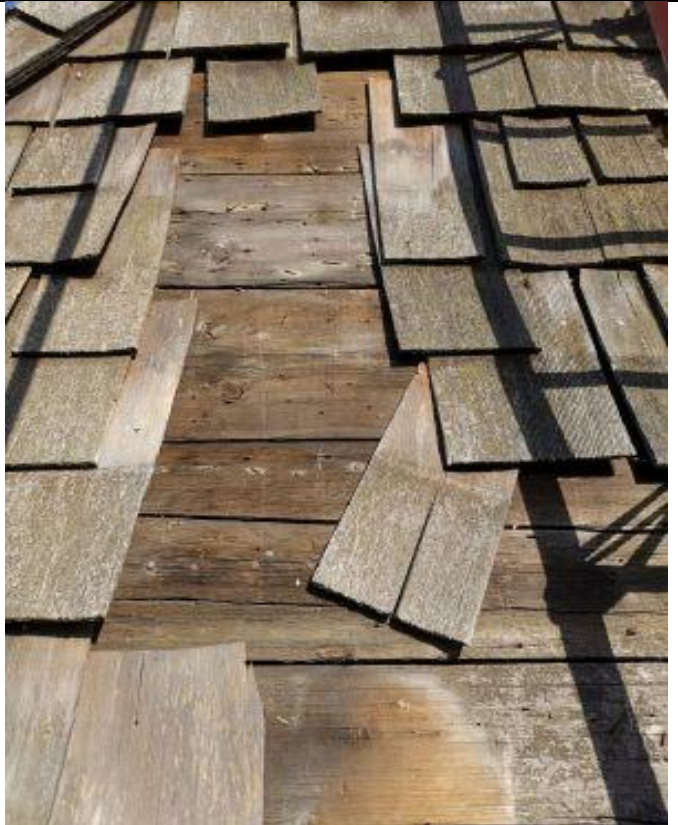
Shingles shown to be degraded and in poor repair. Evidence of nail fatigue on both shingles and sarking board fixings

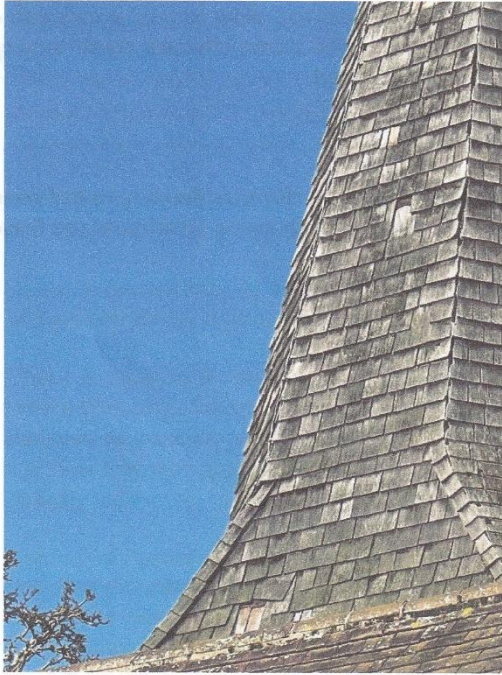
*Slipped and damaged shingles to the Spire.*

- 3.2 The last inspection noted the substantial action of parakeets. During this inspection none were noted which is a relief. However, the condition of the shingling is poor with a number of shingles missing. Inspection from within the Tower indicates that the main structure is dry and well ventilated.

- 3.3 The proposal is made that the repairs to shingles are at least carried out in phases, possibly using a steeplejack to repair the missing and damaged shingles. It is appreciated that this is a less thorough job than fully re-shingling the Spire and does not allow for the installation of a metal underlay behind the shingles. However, it may provide a cost effective repair strategy for the parish, albeit one that will need to be regularly revisited.

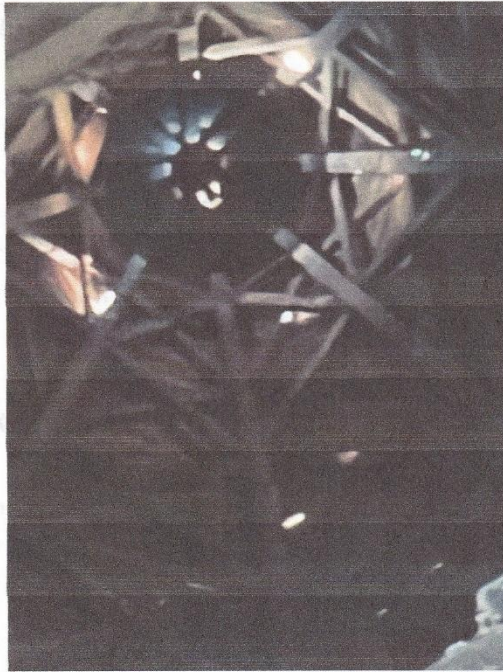
*View up inside the spire showing light through shingles.*

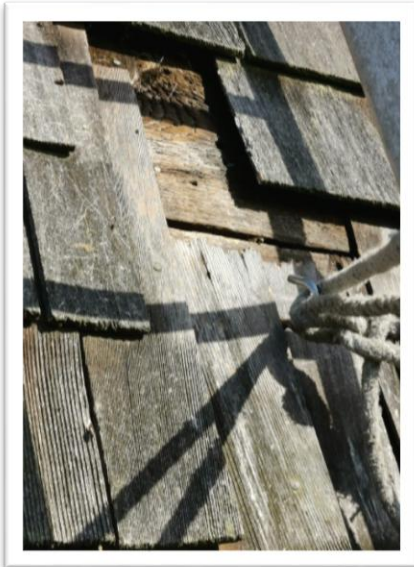
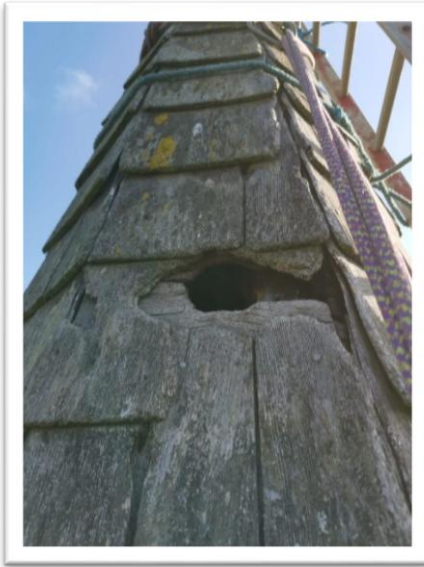
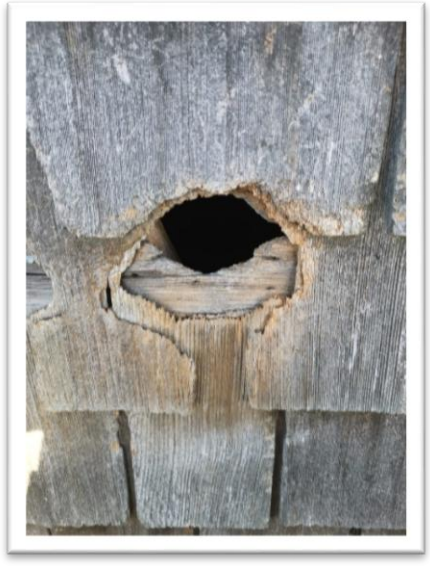
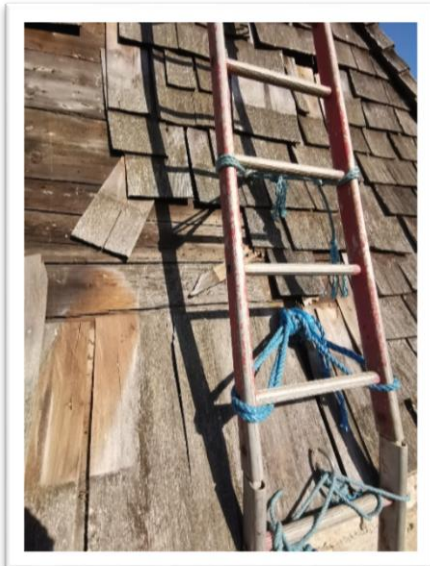
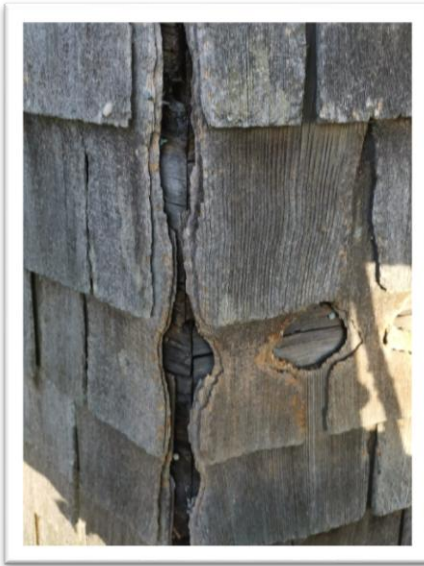
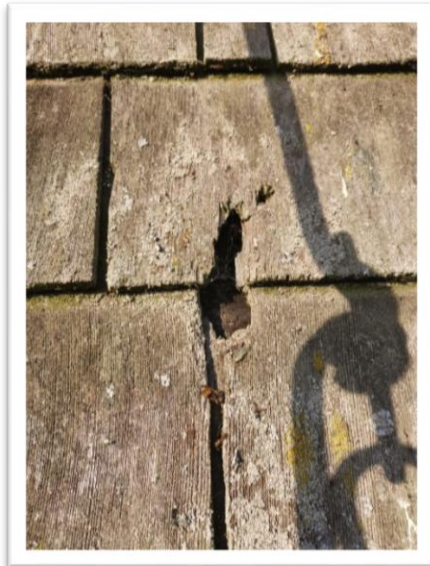
A small selection of photos taken by Steeplejacks during inspection

Unfortunately, the spire is in poor condition due to a bad case of nail fatigue and vermin attack and is beyond economical repair. As seen in the photos, the squirrels have opened up access points to gain entry to the inside of the spire in various elevations, causing damage to the boarding and with the corners being exposed, these will need replacing. Approx. 10 to 15% will need attention. Please note that no covering was removed during the inspection and that it was done purely on a visual and experience basis, and until the existing covering is removed, the extent of any further repairs cannot be seen.
