# St James Church North Cray

## Application Document to support our need to restore the Church spire.

## **St James Church, North Cray**

### **Spire Condition Inspection**

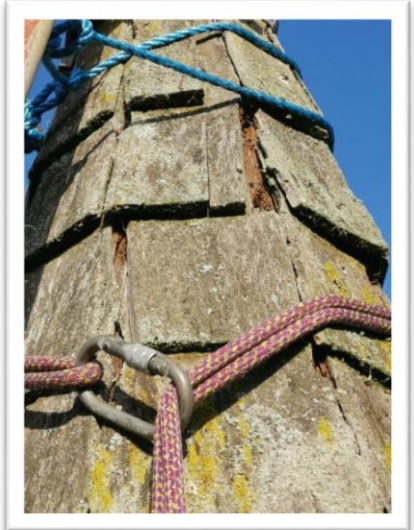
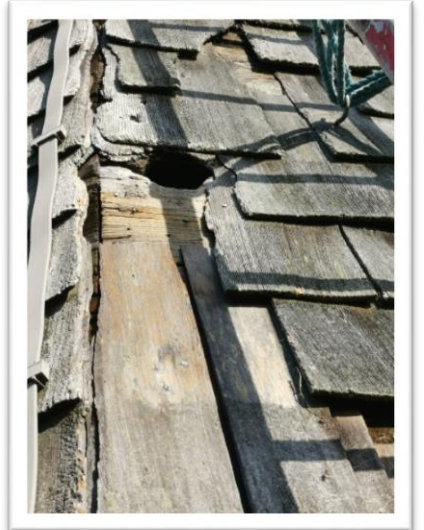
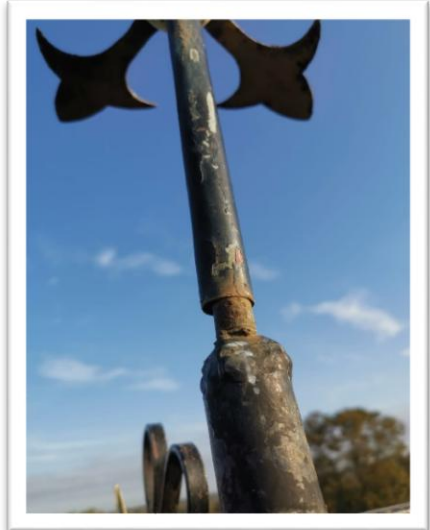
The Survey concluded that unfortunately the spire cladding was beyond economical repair and the only effective remedy would be to completely re clad the spire. A provisional sum should also be included for any necessary repairs/replacements to the backing (sarking) boards.

General view showing typical damage. Both loss of shingles and a hole penetrating the shingles and sarking boards.

Shingles shown to be degraded and in poor repair. Evidence of nail fatigue on both shingles and sarking board fixings

A small selection of photos taken by Steeplejacks during inspection

It is proposed to re-cover the spire in Oak shingles with an exposure gauge of 4" and using 50mm annular ring shank nails. Where necessary the sarking boards would be replaced and all existing and new boards re-secured to the spire structural timbers.
